DEPARTMENT OF TRANSPORTATION

Contract #: 04-0120F4Cty: SF/Ala Rte: 80 PM: 13.2/13.9File #: 69.28**WELDING INSPECTION REPORT****Resident Engineer:**Siegenthaler, Peter**Address:** 333 Burma Road**City:** Oakland, CA 94607**Report No:** WIR-018160**Date Inspected:** 03-Nov-2010**Project Name:** SAS Superstructure**OSM Arrival Time:** 1900**Prime Contractor:** American Bridge/Fluor Enterprises, a JV**OSM Departure Time:** 700**Contractor:** Zhenhua Port Machinery Company, Ltd (ZPMC), Changxing Island **Location:** Shanghai, China**CWI Name:** See below**CWI Present:** Yes No**Inspected CWI report:** Yes No N/A**Rod Oven in Use:** Yes No N/A**Electrode to specification:** Yes No N/A**Weld Procedures Followed:** Yes No N/A**Qualified Welders:** Yes No N/A**Verified Joint Fit-up:** Yes No N/A**Approved Drawings:** Yes No N/A**Approved WPS:** Yes No N/A**Delayed / Cancelled:** Yes No N/A**Bridge No:** 34-0006**Component:** Tower and OBG Components**Summary of Items Observed:**

OBG Trial Assembly Area

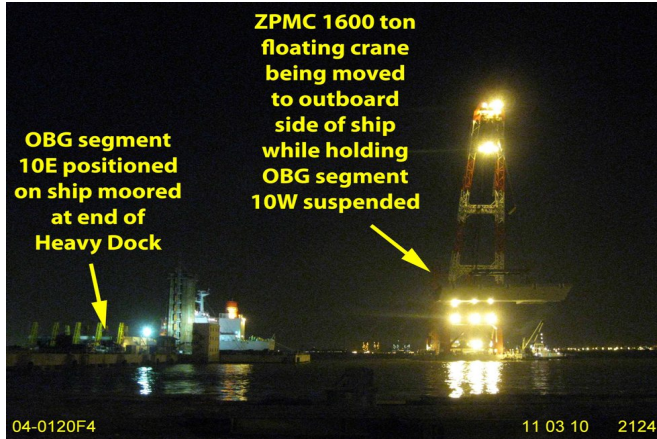
All 4 towers, lift 4 were positioned on a base pedestal at end of the Heavy Dock. West and north towers, lift 3 and OBG segment 10E were positioned on the deck of the ship moored at the end of the Heavy Dock. OBG CB14 was positioned on the deck of the Heavy Dock. No welding related work was being performed on any of the tower or OBG components. The ZPMC 1600 ton floating crane lifted OBG segment 10W from the seawall area at the head of the Heavy Dock and held it suspended while 2 tugboats moved the crane barge to the outboard side of the ship. See photo below. The OBG segment 10W was still suspended over OBG segment 10E when this QA Inspector departed the area.
